Technical Note

15.09.2022

- HYDLLA2000L8D - LLA, 8 PRODUCT, DISPENSER POWERED

An investigation of the issue revealed errors in the silkscreen of HYD90099216 - LLA - PCB, DISPENSER POWERED which carried on into the component HYD90099221 - LLA - HARNESS, LINK CABLE, quick start guide and manual

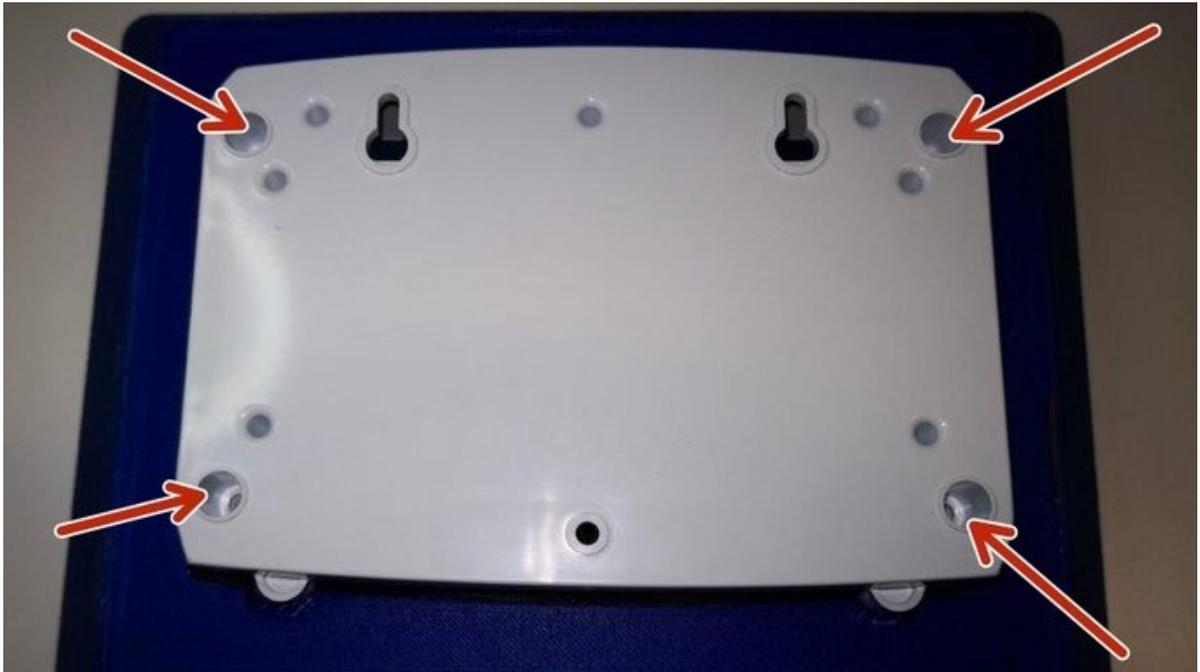
Picture 1: Backside of Low Level Alarm

1. Switch off the EvoClean the LLA connects to and disconnect the EvoClean from the power source.
2. Remove the device from the wall and gain access to the back of the device.
3. Unscrew the marked screws:

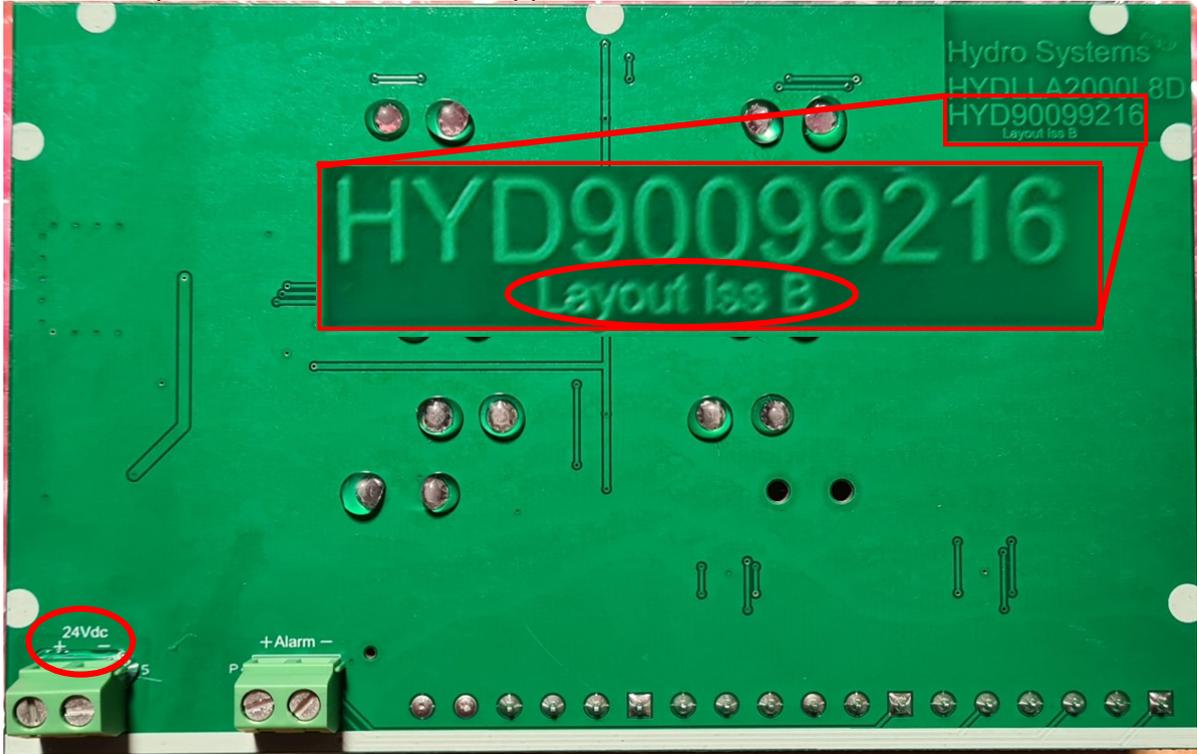
Picture 2: Backside of PCB

4. The backside of the PCB is now visible. Check the Revision of the PCB. If you got the layout issue (Revision) A or B your board does include the error. The error is that the silkscreen print of “+” and “-” is swapped.

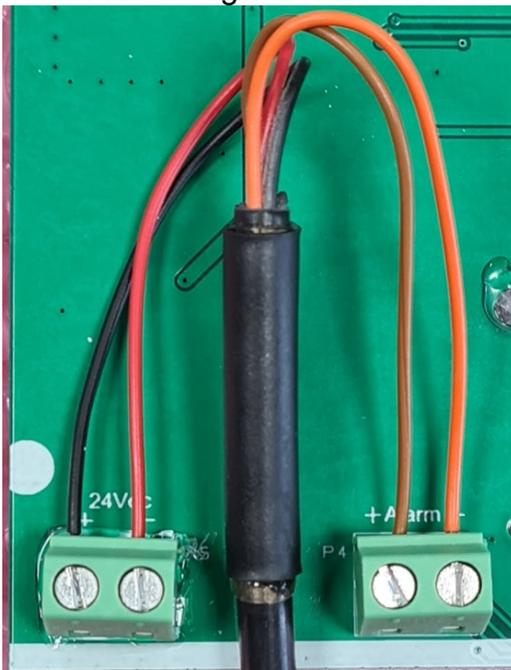
Picture 3: Correct wiring for Revision A and B of LLA Dispenser powered PCB

5. Check the wiring of the 24V Power Cable. For Rev A and B it should look like this:

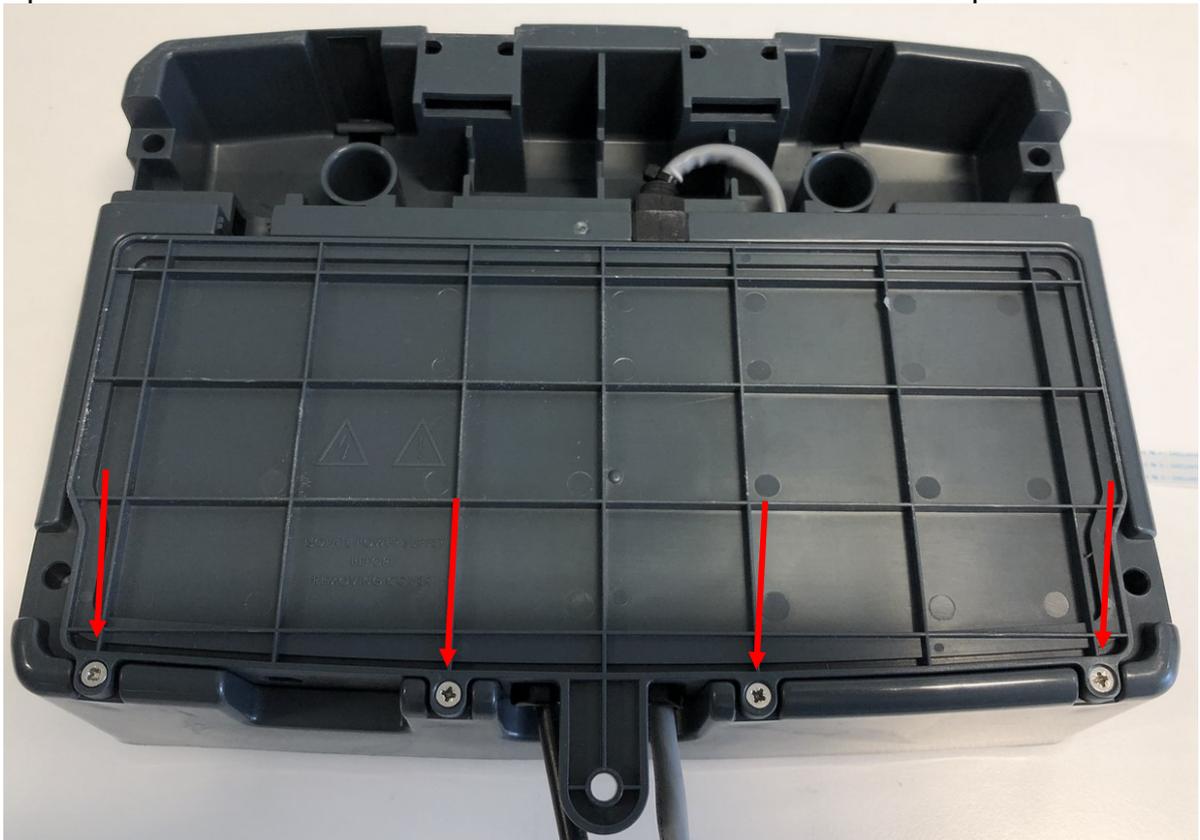
Picture 4: Backside of 4 Product EvoClean

1. Switch off the EvoClean the LLA connects to and disconnect it from the power source.
2. Remove the device from the wall and gain access to the back of the device.
3. Open the rear electronic cabinet. Unscrew the marked screws and open the lid.

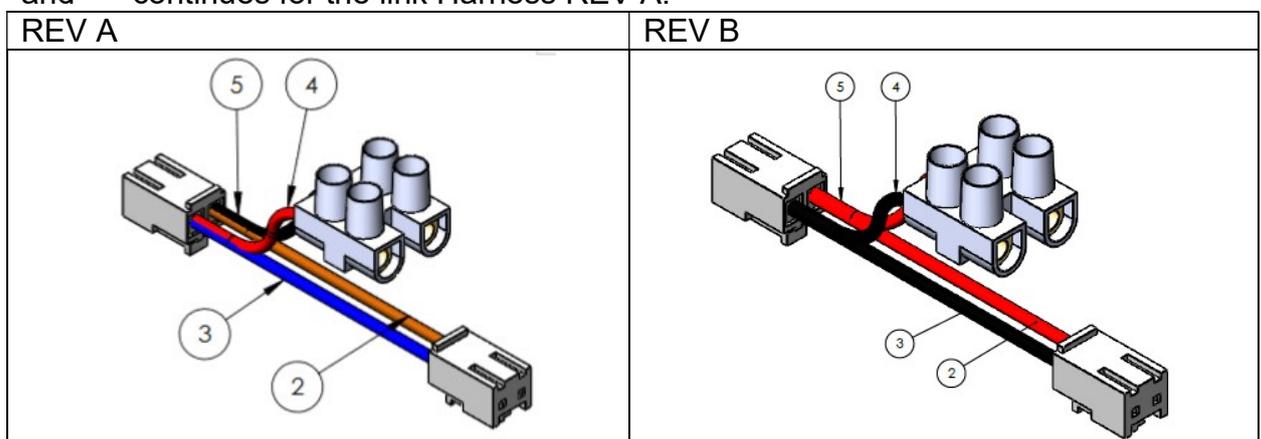
4. Check the wiring of the Link Harness (HYD90099221). The error of the swappend “+” and “-“ continues for the link Harness REV A.

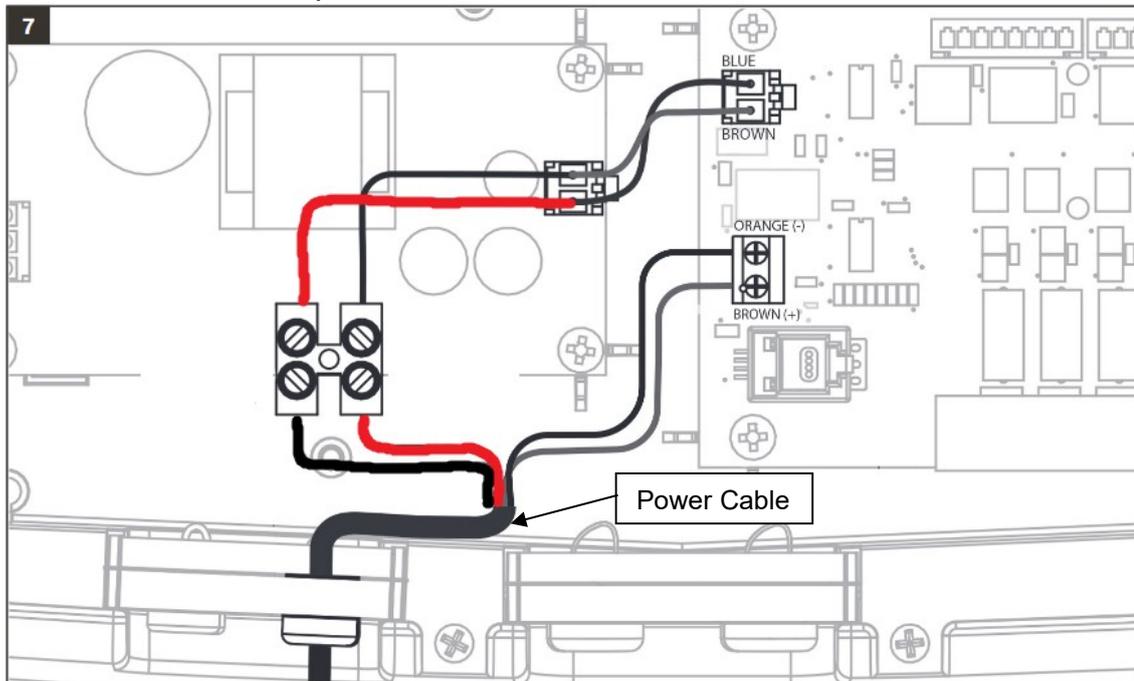
Picture 5: Wiring schematic - Compensation of wrong Link Harness wires.

- If you have REV A version of the link Harness, connect the red cable of the power to the black line of the link harness and the black power lead to the red line of the link harness, as shown in picture 5.

- Your device should now report Low Levels correctly.
- Reassemble the unit

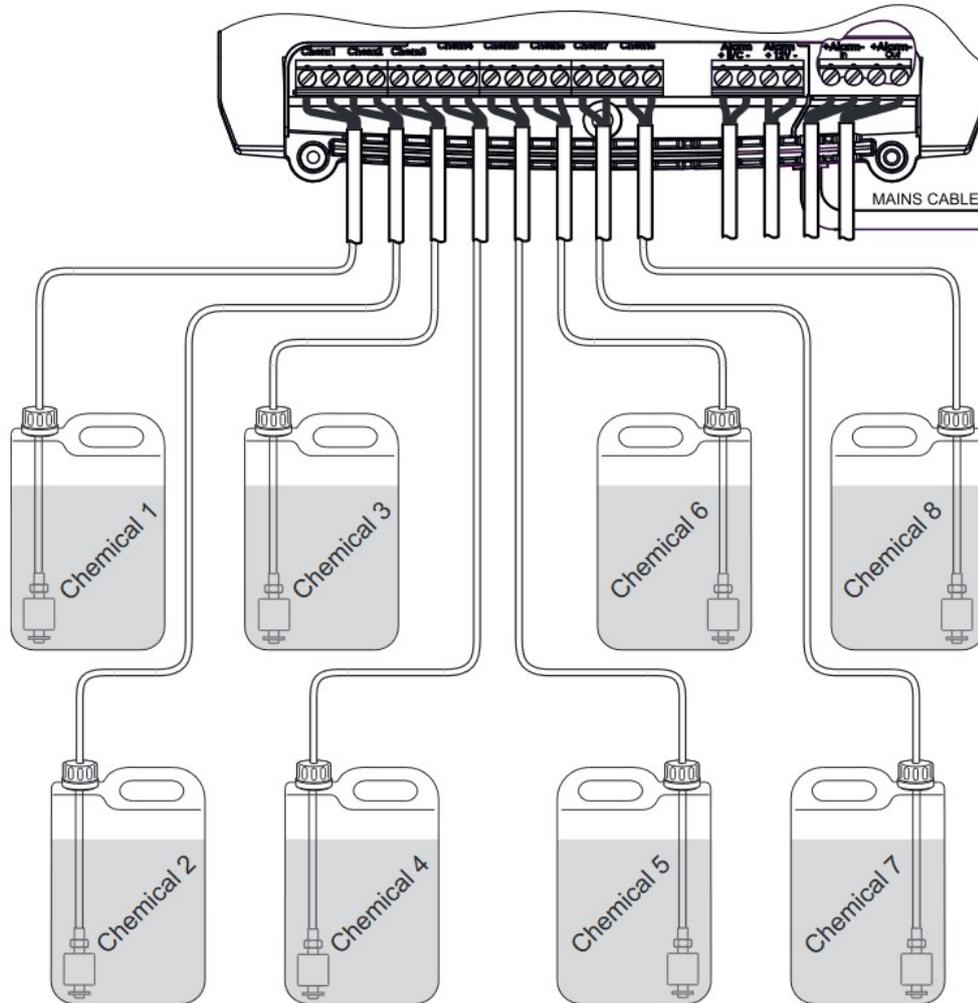
Picture 6: Schematic view of sensor wiring

Pull a sensor out of the chemical until the float is exposed. The alarm should now go on.
